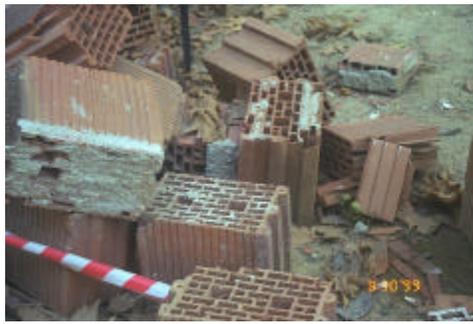
Figure 6 Hollow clay tile blocks from a failed infill wall

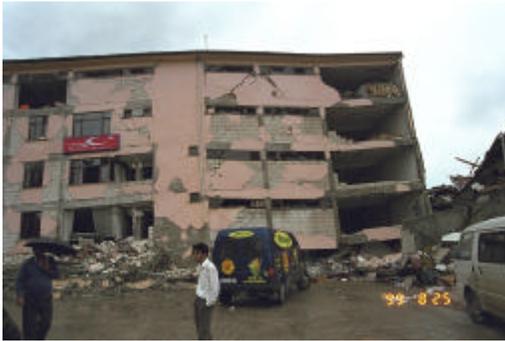
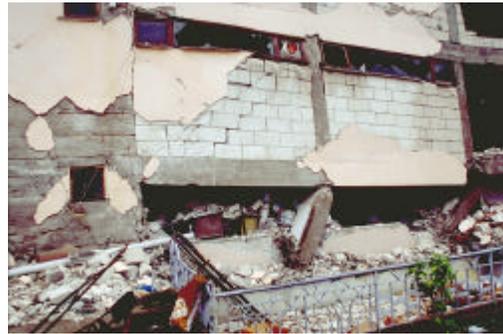
Figure 21 Collapsed dual wall-frame building in Adapazari, (a) view of collapsed 5-story building, (b) failure of the shear wall and perimeter columns

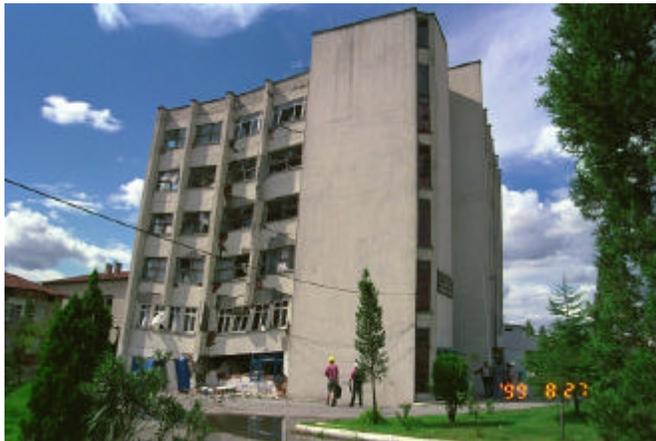
Figure 22 Damaged wall frame building due to ground failure and wall rotation

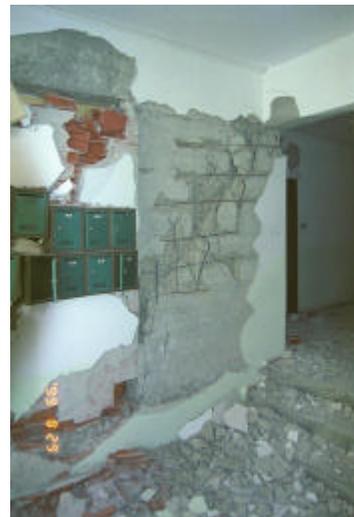
Figure 23 Shear failure of wall/blade column
