Proceedings ITU-IAHS International Conference on the Kocaeli Earthquake 17 August 1999: A Scientific Assessment and Recommendations for Re-Building, M Karaca and D. N. Ural, editors, Istanbul Technical University 1999, ISBN 975-561-166-5, pp. 193-204.

Earthquake Damage, Site Response, and Building Response in Avcilar, West of Istanbul, Turkey

Edward Cranswick¹, Oguz Ozel², Mark Meremonte¹, Mustafa Erdik², Erdal Safak¹, Charles Mueller¹, Dee Overturf¹, Arthur Frankel¹

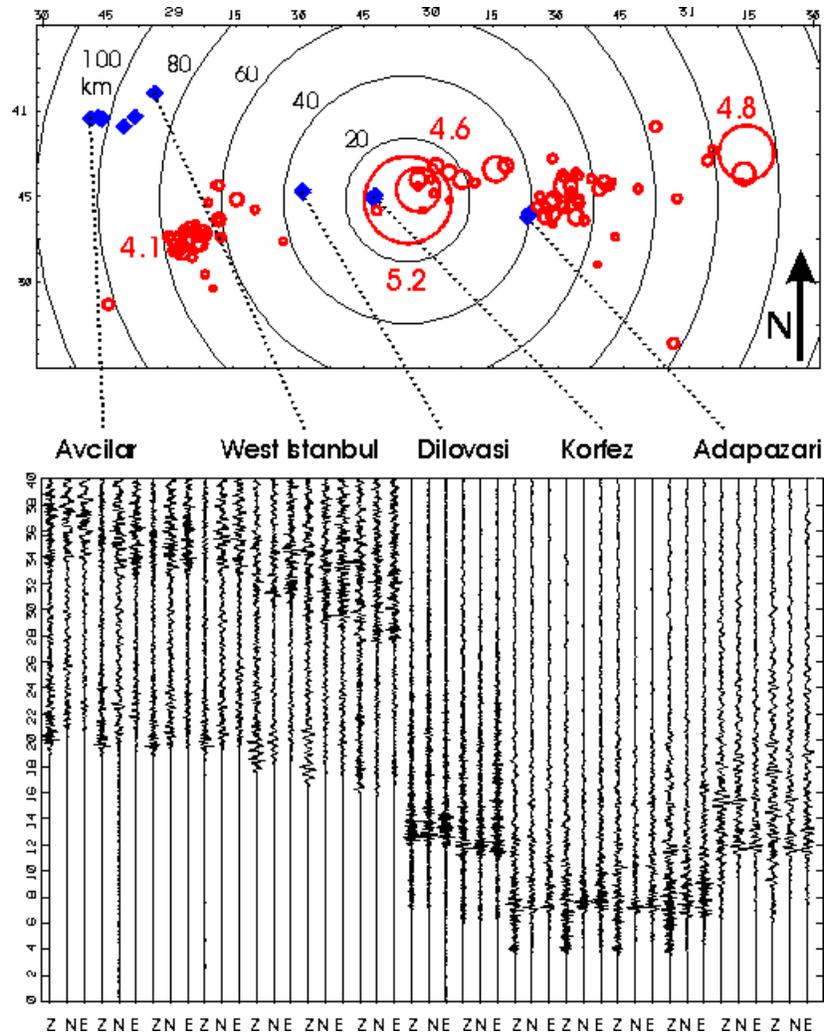
Figure 1: A) Map of Kocaeli Earthquake aftershock zone. The black concentric circles centered on the mainshock epicenter are in 20-km increments. The red circles are aftershock locations (from Seismological Observatory, KOERI: <http://www.koeri.boun.edu.tr/geophy/anasayfa/eanafir.html>) | Seismology | **Recent Earthquakes Text**) and their radii are proportional to Brune-source radii, the magnitudes of the four largest events are annotated. The blue diamonds are the locations of individual seismographs and/or small-aperture seismic arrays, and they are connected by dotted lines to the town names of the recording sites. B) The corresponding three-components (Z, N, E) of ground motion recorded at these sites are shown as a pseudo-recordsection of 40-s duration. The amplitudes of each trace are normalized to the peak value of that trace, i.e., amplitudes cannot be compared. Strong-motion records are plotted as acceleration in the eastern epicentral region, weak-motion records are plotted as velocity in Avcilar and West Istanbul.

Figure 1A is a map showing instrument locations and epicenters of aftershocks recorded by at least one station during the initial deployment. From west to east, the map shows instrument deployments in Avcilar, West Istanbul, Dilovasi, Korfez, and Adapazari. Figure 1B shows the three-component records produced at these sites by a magnitude-5.2 (M5.2) aftershock (August 31 08:10) that has almost the same epicenter as the mainshock (see Figure 1A).

The four largest recorded aftershocks constitute a good sample of the three or four main source regions of the Kocaeli Earthquake (see [Figure 1A](#)), and in the frequency band <0.25 Hz (>4-s period), their records exhibit large-amplitude phases after the S-waves at stations in the damaged area of Avcilar that do not appear at stations in less damaged or undamaged areas further to the east. The damaged area of Avcilar is located on an east- and south-dipping hillside that rises fairly steeply, relative to adjacent topography, from the shores of the Sea of Marmara to the south and Kucuk Cekmece to the east. The large-amplitude phase may be related to body-wave/surface-wave conversion at these topographic boundaries and/or to higher-mode surface-wave amplification from the local thickening of low-velocity layers. There is no question that both the building and site responses have spectral complexities that overlap. This may explain why Avcilar, which is even further from the epicenter than Istanbul proper, suffered more damage during the Kocaeli Earthquake.

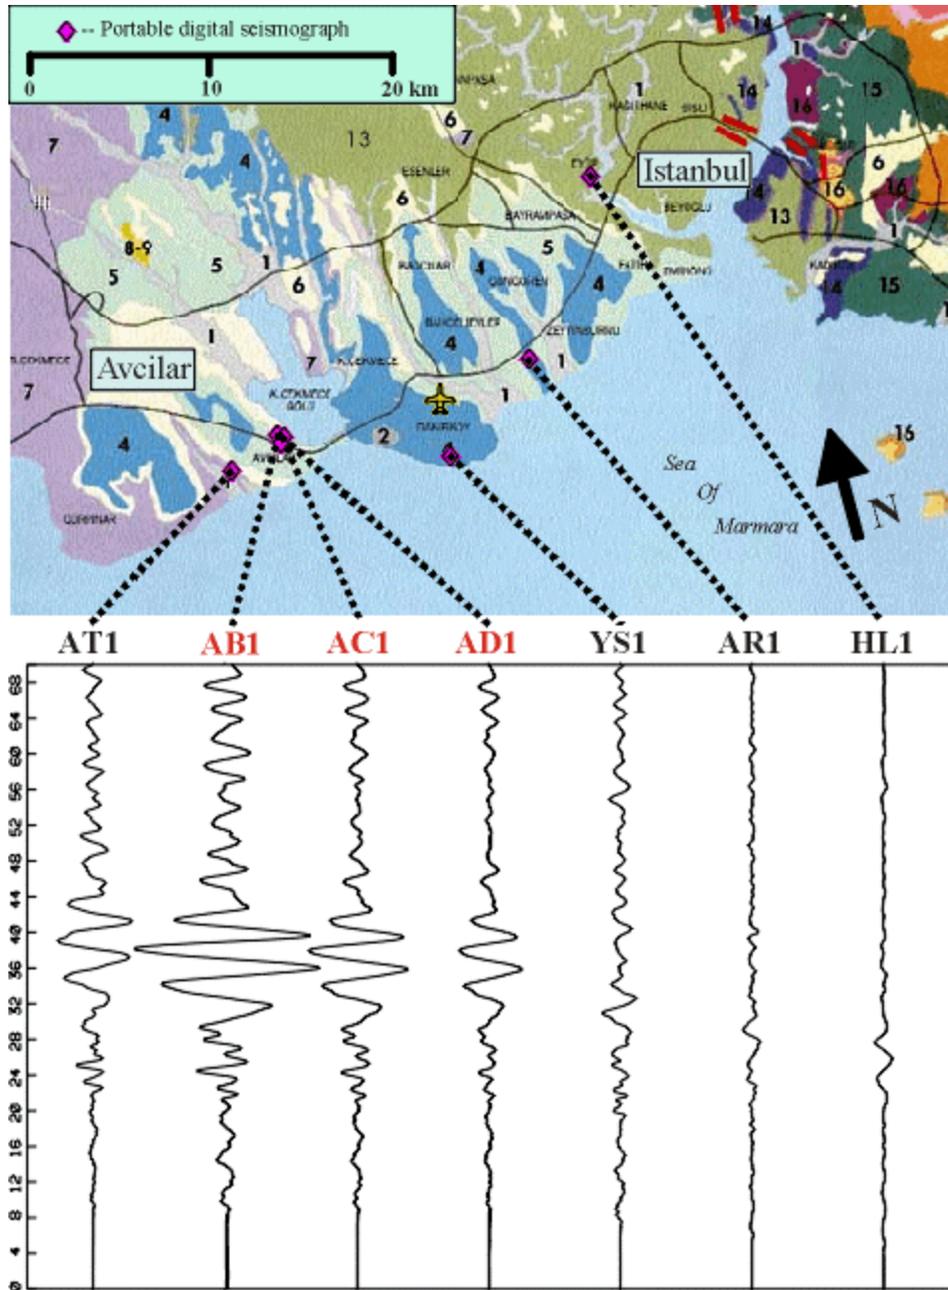
Figure 2: A) Geotechnical surficial geology map of Avcilar and West Istanbul (Municipality of Istanbul): [1-3] alluvium with low-loading capacities where load capacity increases from 1 to 3; [4] alluvium with good loading capacity with weak zones locally; [5] alluvium with low-loading capacity with increase probability of landslides on slopes reaching 14-15 degrees; [6] alluvium with high-loading capacity but landslides may occur where ground water accumulates at bottom of slopes; [7] alluvium with low-loading capacities with known damage to structures; [13] rock with high-loading capacities except on slopes. B) The radial components that have been low-pass filtered at 0.25 Hz (4.0 s) exhibit Rayleigh waves that are significantly amplified at sites in the damaged area of Avcilar.

To investigate the pattern of damage produced by the mainshock, *i.e.*, little damage to the Istanbul proper but greater damage to its western suburbs, we deployed seven portable seismographs at sites in Avcilar and West Istanbul to record aftershocks. These included a small-aperture (~200 m), tripartite array in the damaged neighborhood of Avcilar (AB1, AC1, AD1), and an instrument (AT1) co-sited with a digital strong-motion accelerograph ~1 km west of town that recorded the mainshock (KOERI Station ATS; 0.24% g). Avcilar and vicinity is underlain by as much as 200 m of poorly lithified calcareous sand, marl, and oolitic limestone (Upper Miocene) and unconsolidated Pliocene sand and gravel (Kapp *et al.*, 1969). For the purpose of this study, we will refer to this strata as "soft rock". To acquire a representative sample of ground motion from the soft rock strata, we deployed two other stations: at Yesilkoy (YS1) where there was some damage and near the Istanbul airport (AR1) where there was no damage. We also deployed a station at a reference rock site (HL1; underlain by Devonian limestones and greywackes) that we selected as being representative of strata beneath the undamaged areas of Istanbul proper. Figure 2A shows the locations of these stations with respect to the geotechnical properties of the underlying strata. The radial components of ground velocity of the M5.2 aftershock recorded at these sites, low-pass filtered at 0.25 Hz (4.0-s period), are shown in the W-E pseudo-recordsection of Figure 2B. Station AT1 was equipped with a Guralp broadband seismometer, and its records have been high-pass filtered with a 2-pole Butterworth at 2 Hz to give them the same response characteristics as those of the other stations equipped with L-22 geophones. Station AT1 and the three stations in the

damaged neighborhood, particularly AB1, exhibit large amplitude and very prominent Raleigh waves that begin approximately 8 s after the corresponding S-waves. [Figure 3](#) is a photograph of the remains of an apartment building that stood – before the earthquake – less than 30 m from Station AB1.

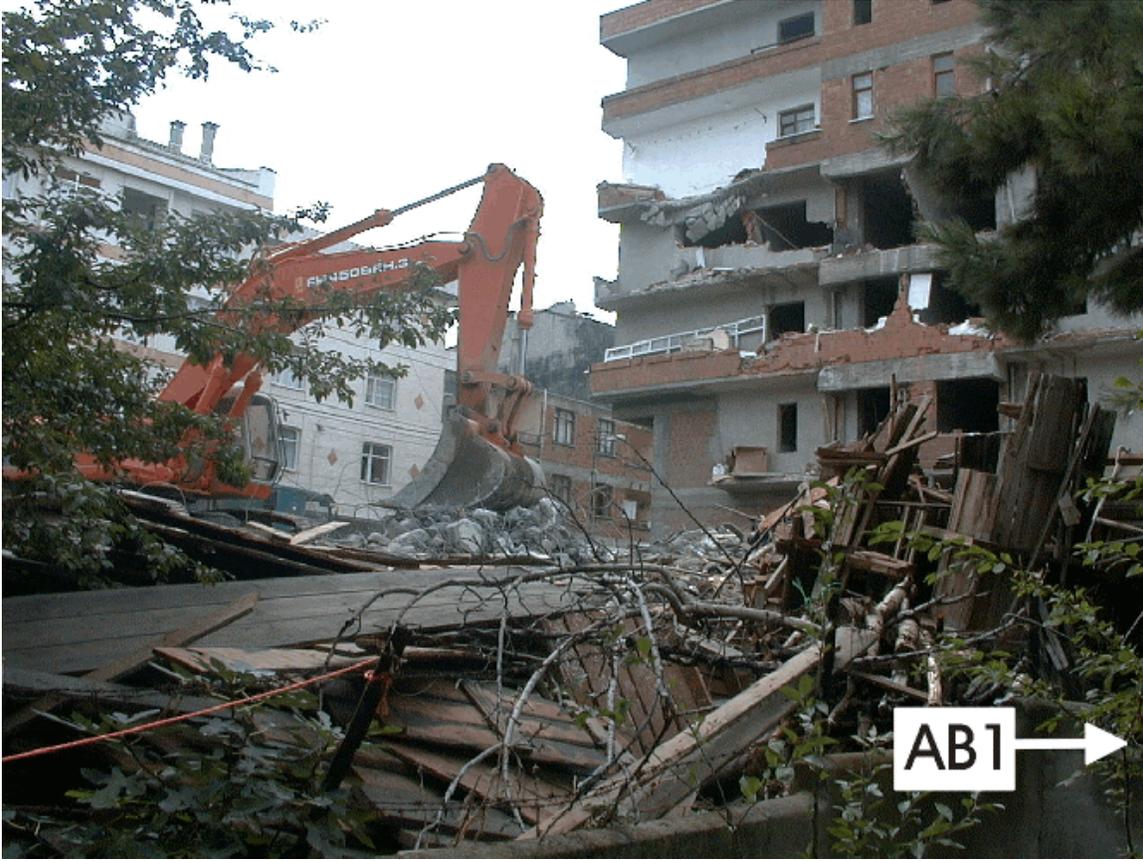
Figure 3: Collapsed 6-story apartment building adjacent to Station AB1 of the small-aperture seismic array in the damaged area of Avcilar.

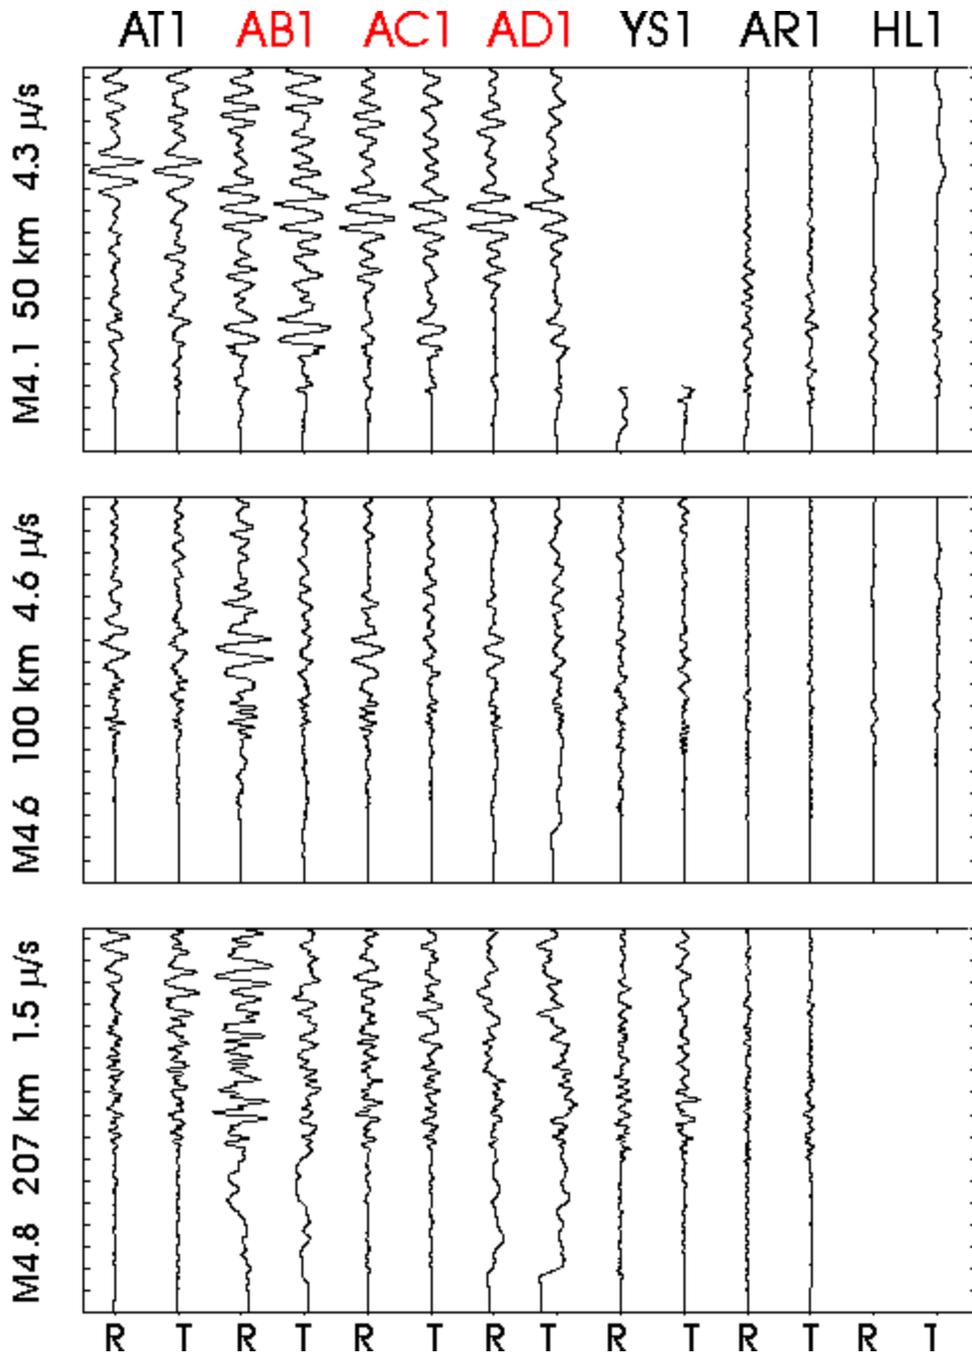
Figure 4: Radial (**R**) and tangential (**T**) ground-velocity components of three of the larger aftershocks; see annotated events in [Figure 1A](#). All records have been low-pass filtered at 0.25 Hz and plotted at the same time scale with a 70-s duration. The records of each event are plotted at the same amplitude scale and the peak amplitude is annotated with the magnitude and epicentral distance on the left.

[Figure 4](#) displays the pseudo-recordsections of three other large aftershocks (M4.1, 4.6, 4.8) recorded by the stations shown in [Figure 2](#). In general, ground motions <0.25 Hz in the damaged area are 2-4 times greater than those of the less damaged and undamaged areas underlain by similar geology, *i.e.*, Yesilkoy and the "soft-rock" site, and an order of magnitude greater than those at the rock site. The consistency of the ground motion amplification of the damaged sites relative to that of the undamaged sites over a range of epicentral distances that spans 200 km (50, 100, 207 km) suggests that regional focusing effects, such as those that produce SmS phases, do not contribute significantly to the amplitude differences. In the frequency band >1.0 Hz, the ground velocities of more than 50 aftershocks are consistently higher at Yesilkoy than at the other sites, and this may be due to a localized surficial layer of low-velocity unconsolidated sediments at Yesilkoy. Station AT1 regularly recorded ground motions that were smaller but comparable to those of Station AB1, and that station is colocated with a permanent station that recorded the largest peak accelerations in Istanbul during the mainshock. However, the mainshock caused little damage here, presumably because the plant consists of buildings and structures that are less fragile than the surrounding apartments.

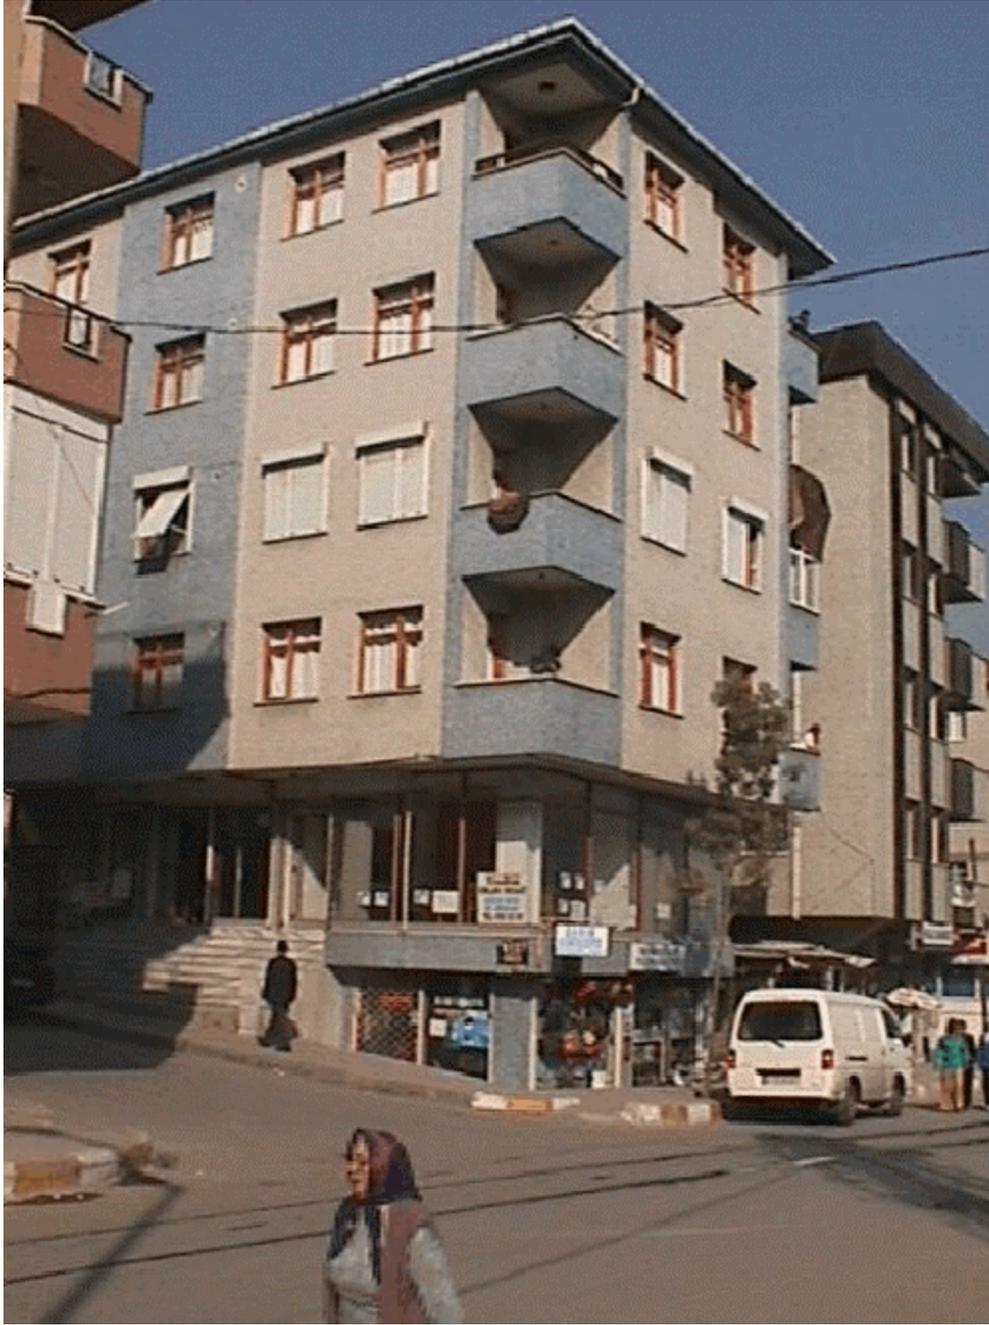
Figure 5: Building in the damaged area of Avcilar that we tested in this study. Note that the building has six stories in the front and less than that on the side with the stairs. This building is approximately 100 m south of the building that collapsed adjacent to Station AB1.

We evaluated the response characteristics of a building located within the area of the small-aperture array in the damaged neighborhood of Avcilar ([Figure 5](#)). Other than some minor cosmetic cracking of stucco, plaster and tiles, the building is apparently undamaged, even though at least four buildings adjacent or in close proximity to, *i.e.*, within the damage array, collapsed during the earthquake. The building was instrumented with an L-22 geophone in the basement and another L-22 resting on the concrete ceiling above the 6th floor, below the tile roof. The signals from both sensors were recorded by one 6-channel RefTek PASSCAL 72-08 DAS in both trigger mode at 100/200 sps and continuous mode at 25 sps. [Figure 6](#) displays both the basement and roof records (plotted on the same time and amplitude axes) of a M3.9 aftershock (October 11 02:47, near the M4.1 aftershock near Yalova; see [Figure 1A](#)). Note that the verticals have similar amplitudes but the amplitudes of the horizontal components in the roof are much larger than those in the basement, reflecting the amplification of ground motion produced by the building response.

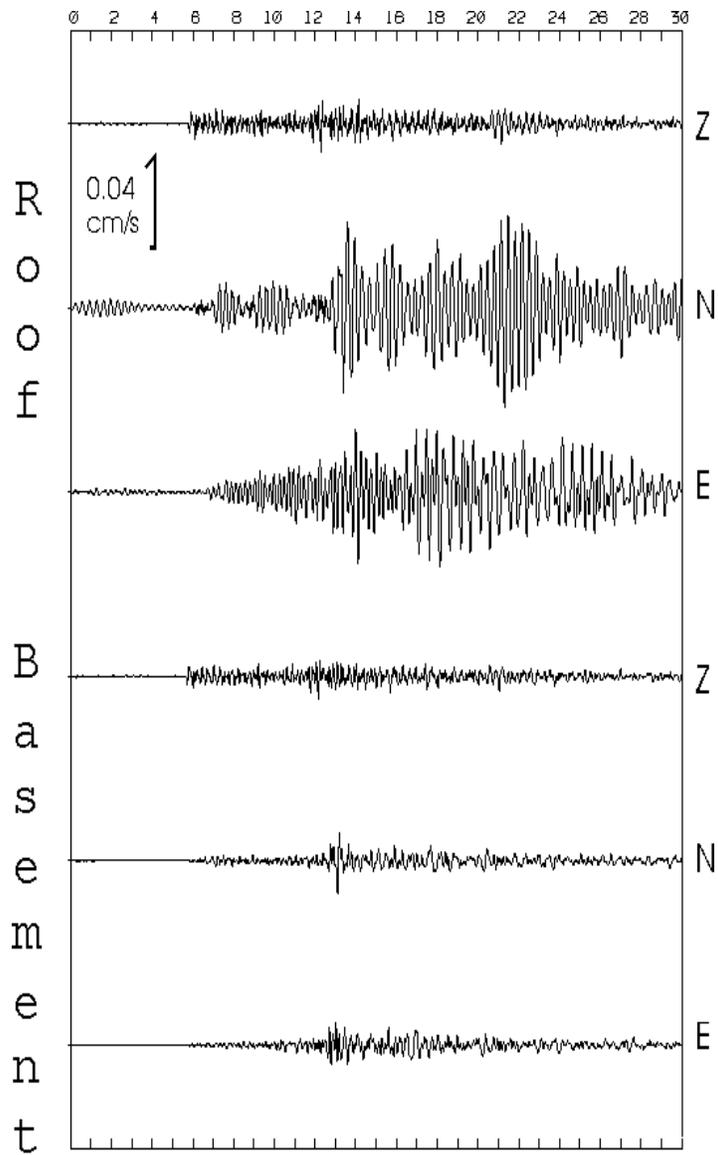
Figure 6: Response of 6-story apartment building to a M3.9 aftershock at a distance of ~40 km. All traces are plotted on the same amplitude and time scales.

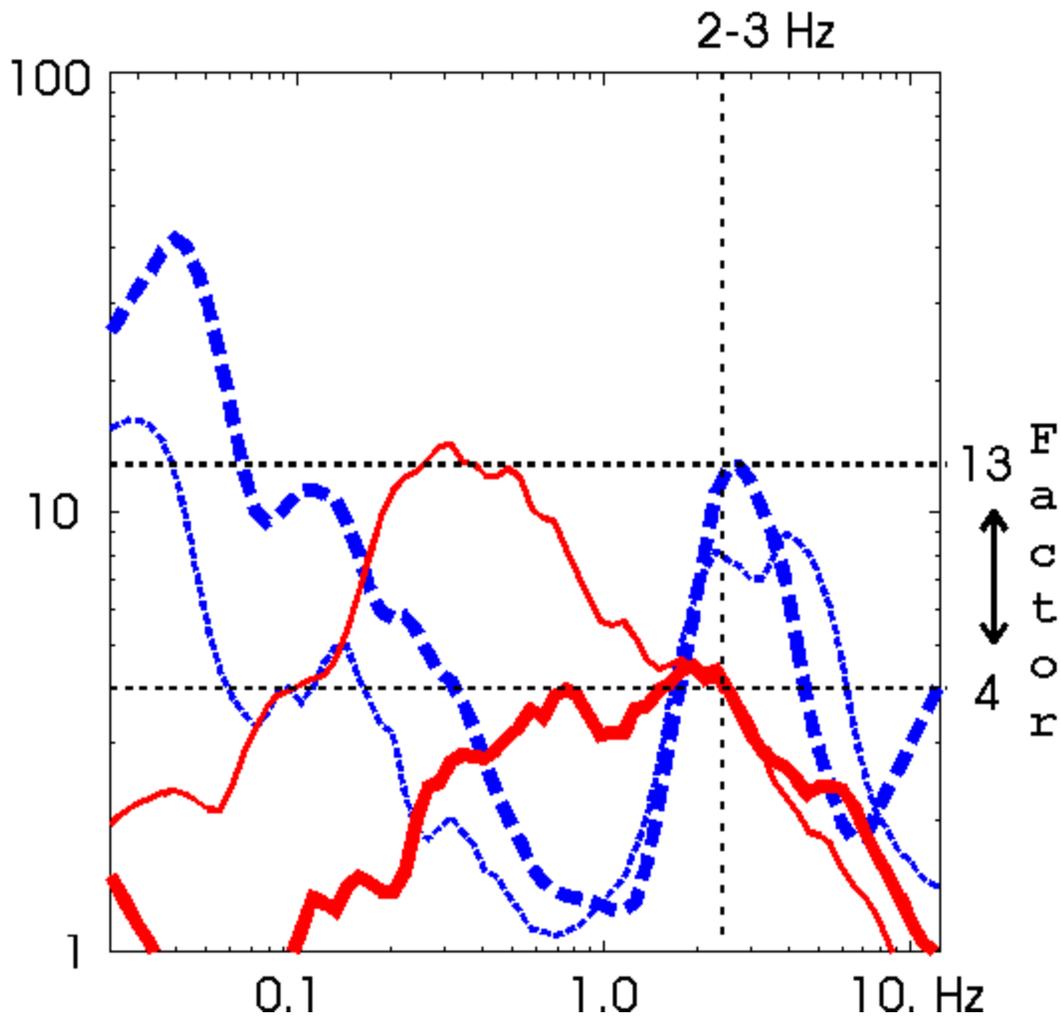
Building response (NS

; EW

)
Site response (radial

; tangential

Figure 7. Spectral ratios that have been smoothed over octave-wide intervals and plotted on the same amplitude and frequency axes.

in Istanbul? To estimate this correlation, we calculated the NS and EW horizontal building responses and the radial and tangential horizontal site responses. The building responses are the ratios of the spectra of the horizontal roof records to the spectra of the corresponding basement records of the M3.9 aftershock (see [Figure 6](#)). The site responses are the ratios of the spectra of the horizontal Station AB1 records to the spectra of the corresponding Station HL1 (reference rock site) records of the M5.2 aftershock. All records are ~80-s long at 25 sps. [Figure 7](#) is a log-frequency/log-amplitude plot of the two horizontal components of both of these spectral ratios, *i.e.*, the building responses and the site responses. Both the NS and EW components of the building response exhibit the peaks between 2-3 Hz that would be expected of the fundamental mode of a 5-6 story building (assuming a period of ~0.1 s per floor), and these peaks have amplitudes – factors of roof/basement amplification – of 8-13. The radial component of site response peaks at 0.3–0.4 Hz with an amplitude – a factor of Avcilar/Istanbul amplification – of 13, and this corresponds to the timeseries amplitudes of Station AB1 relative to other stations as seen in [Figure 2B](#) and [Figure 4](#). The tangential component peaks at about 2 Hz, *i.e.*, at nearly the same frequency as the building response, but it only has an amplification factor of 4. It is not clear why the building responses of both NS and EW components keep increasing at low frequencies.
