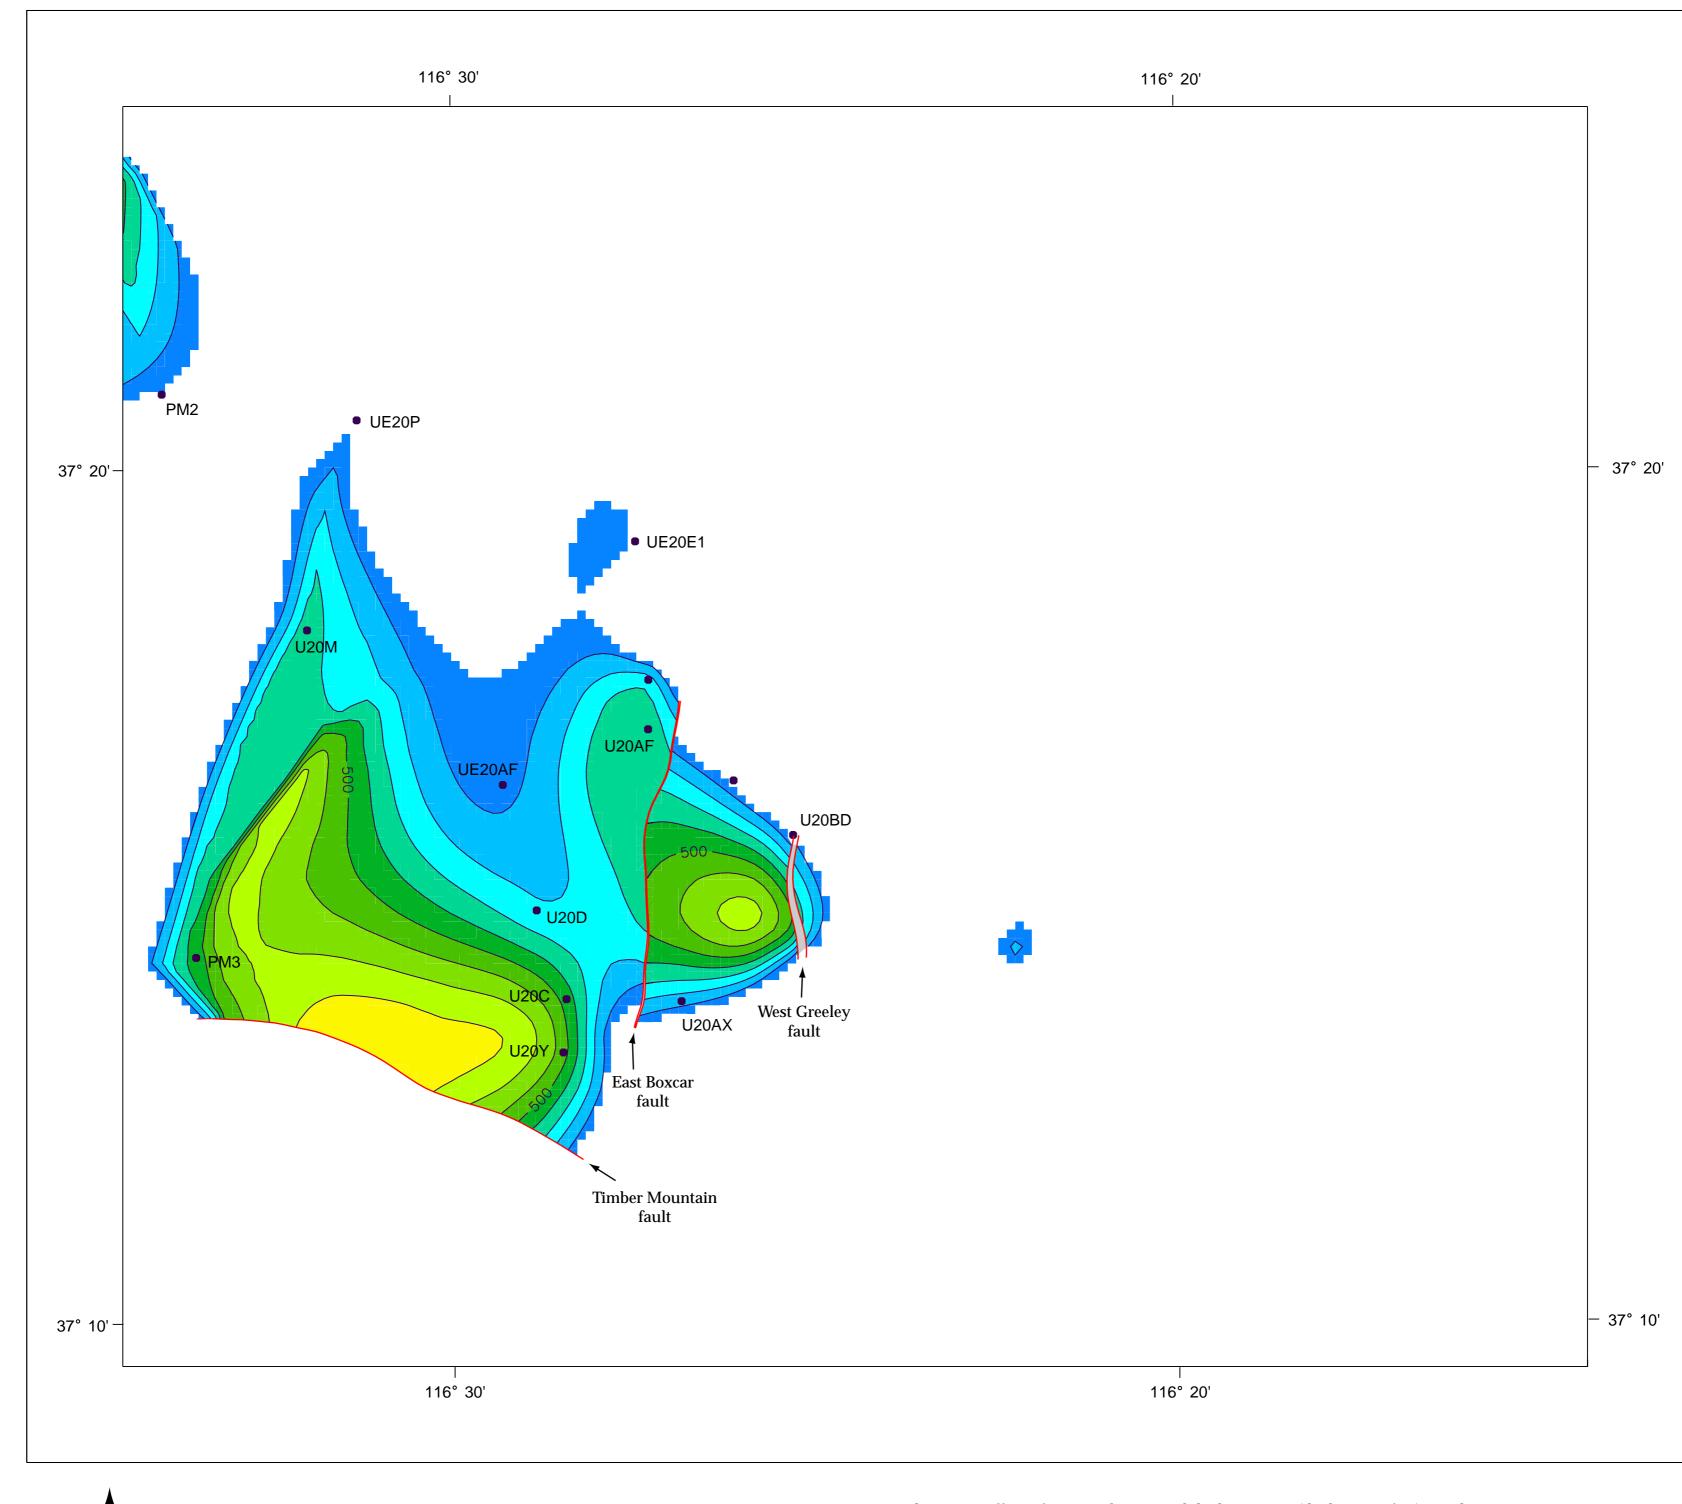
Figure 6a. Topopah Spring tuff aquifer. Distribution and thickness map (thickness in feet). Fault traces are grey where the orientation of the fault is not vertical and a thickness calculation is not possible. Drill holes that penetrate this unit or units stratigraphically beneath it are labelled by number; control points used to constrain the surface in EarthVision are dots. No thickness is shown south of the Timber Mountain caldera fault because of lack of drill hole control.
